**Object:** RELEASE OF A NEW CASTING MOULD FOR PRODUCTION 442710333041 BRP102 HOUSING MALAGA  
LARGE - PAINTED AT LVL SUPPLIER

**Family name:** Coreline \_Malaga\_Led

**Family code:** BRP102

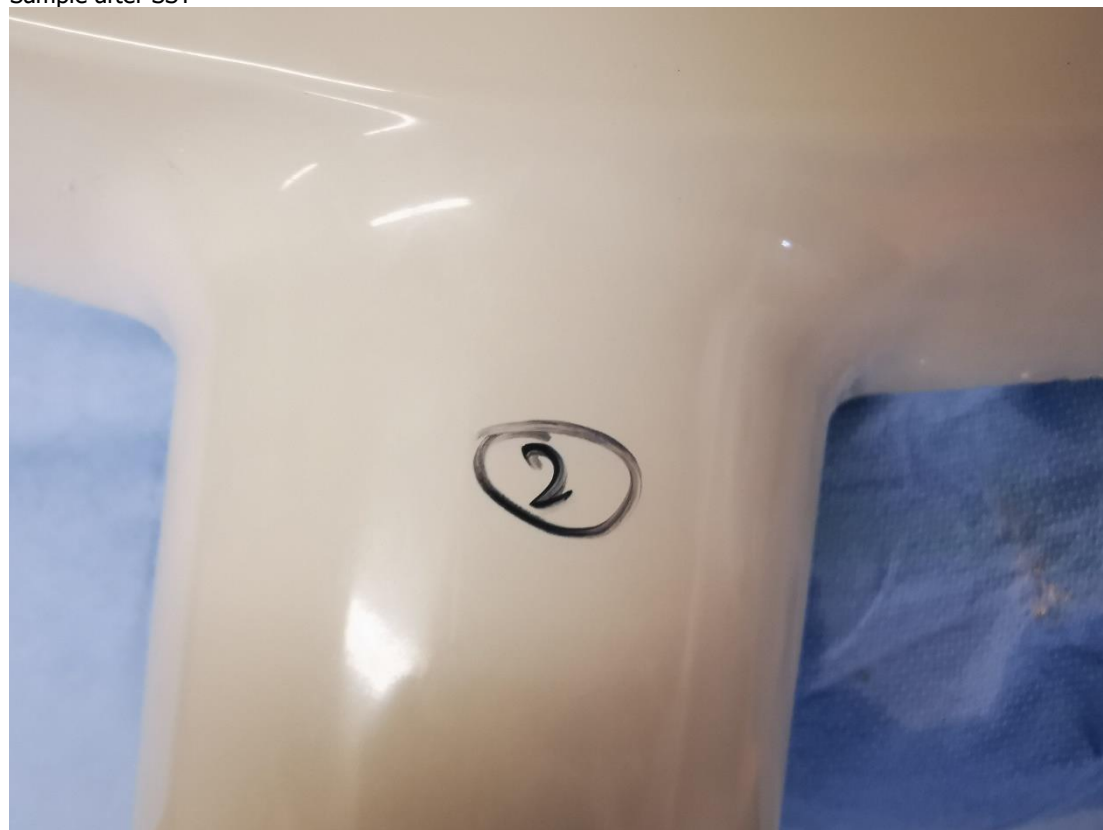
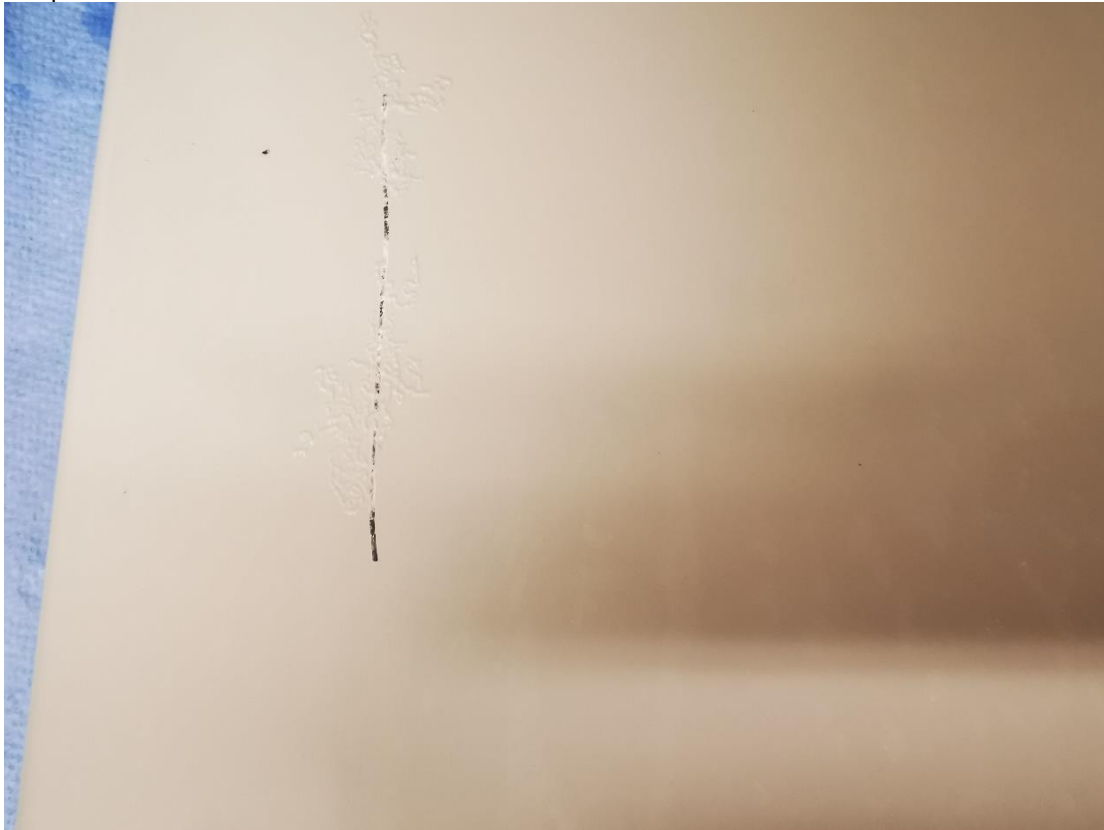
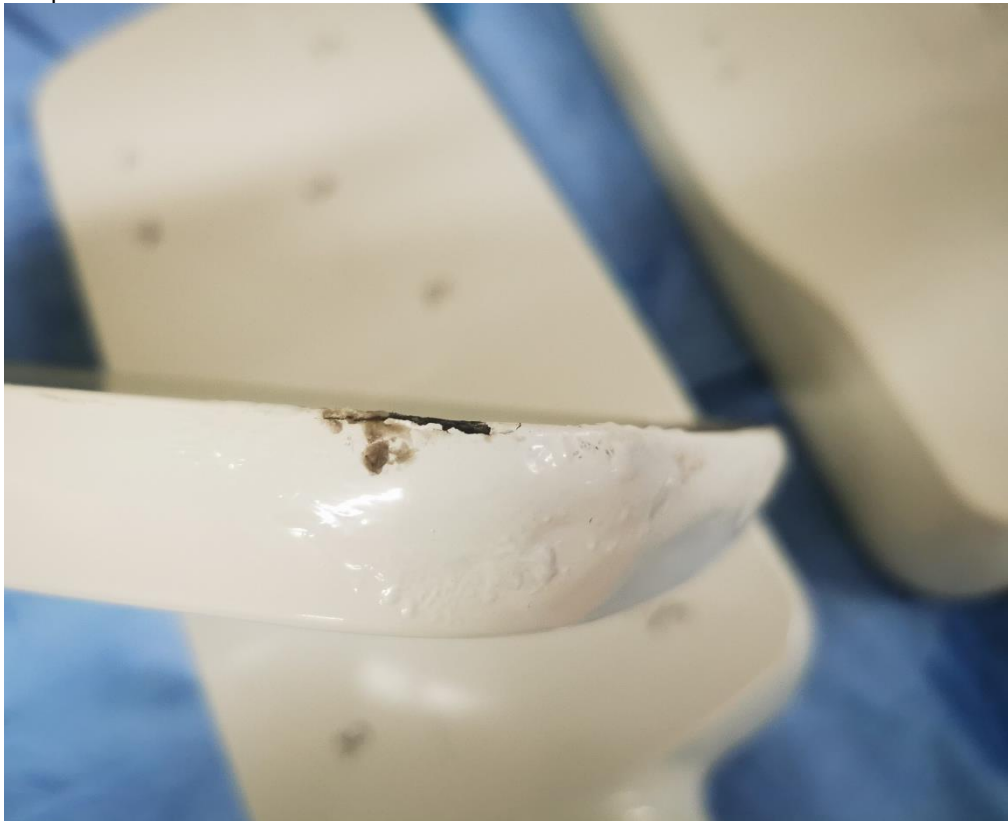
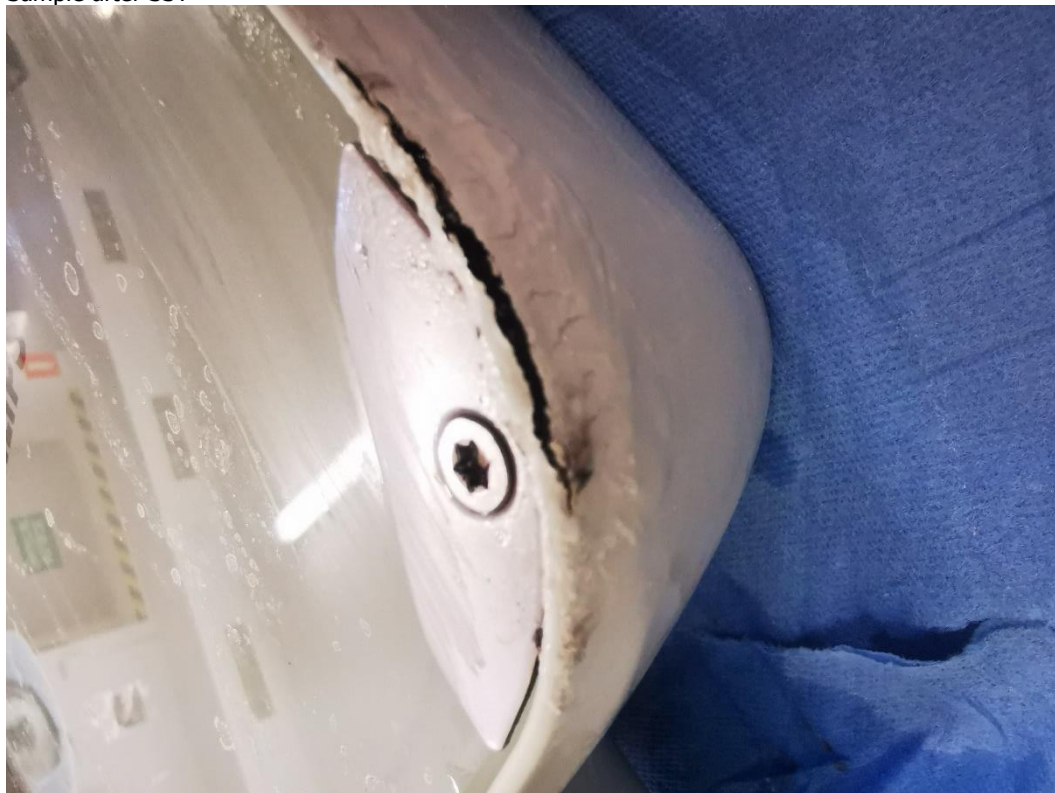
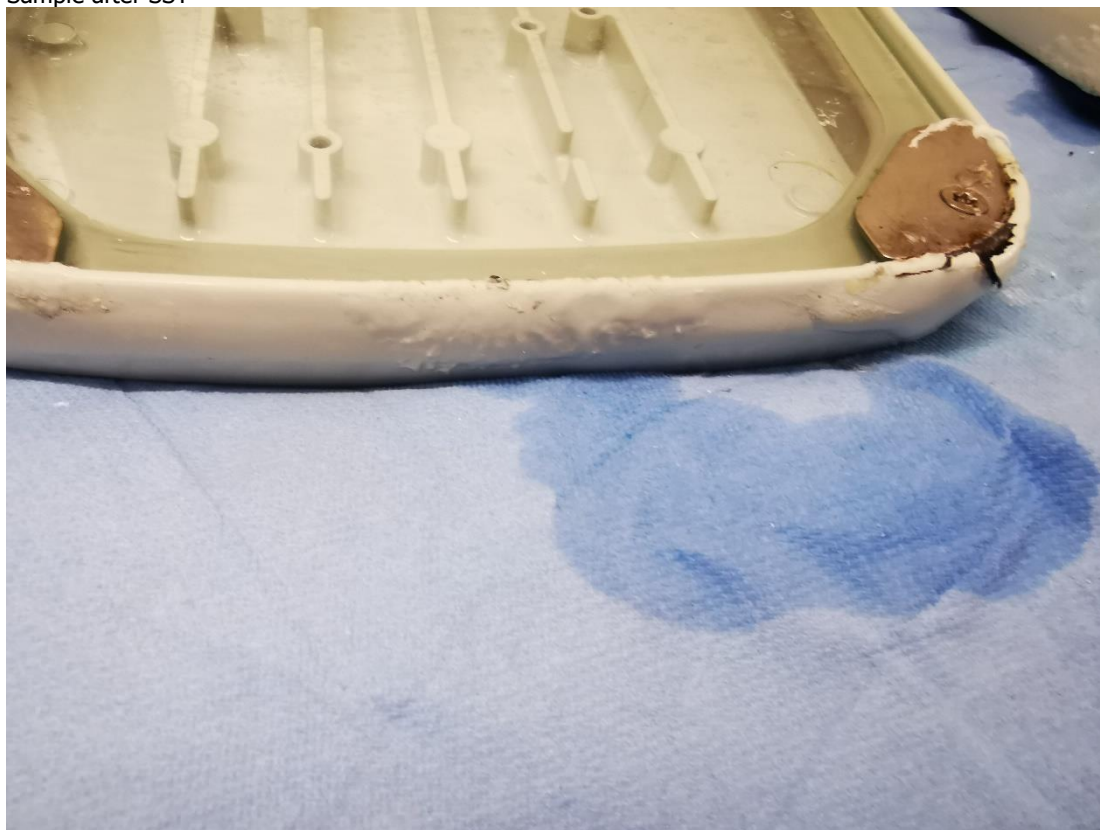
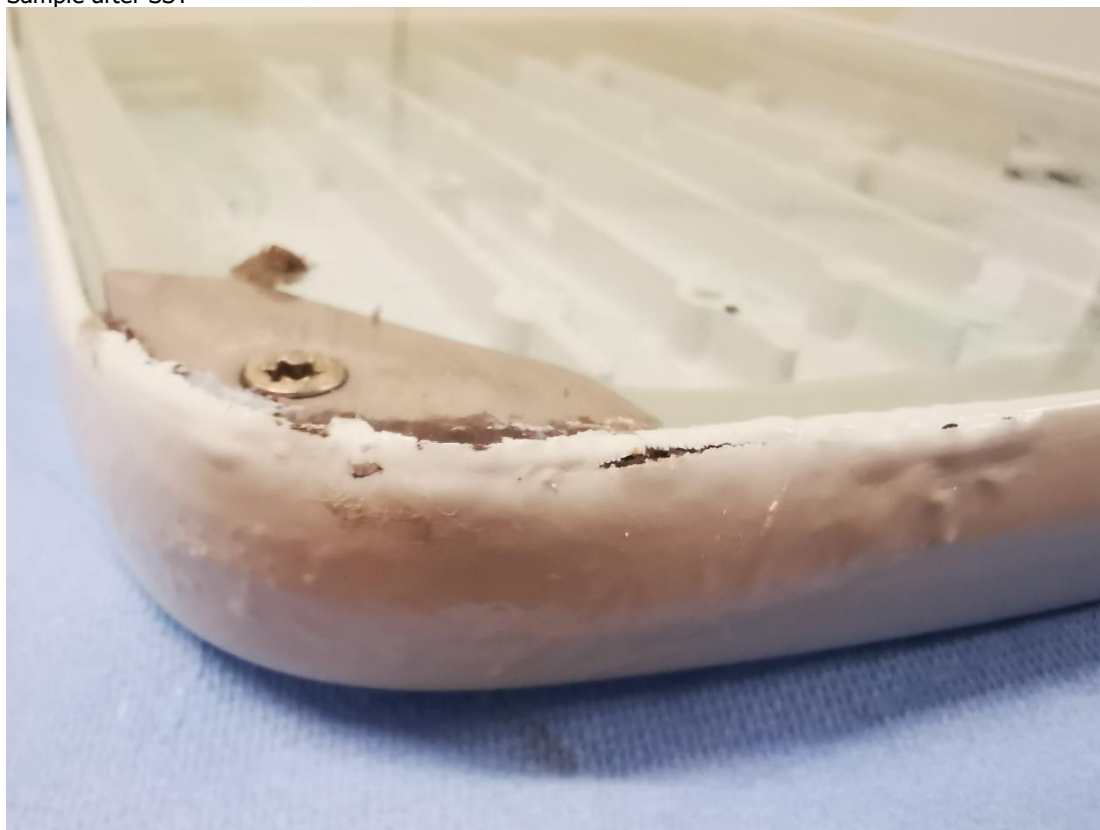
**Check after 500h SST: C = CROSS (CREEP Level)**

SAMPLE		CREEP	Creep level
Sample 1	HOUSING	C1	8
		C2	5
		C1	8
Sample 2	HOUSING	C1	6
		C2	8
		C1	7
Sample 3	HOUSING	C1	5
		C2	9
		C1	9

Sample after SST

rust penetration length around an edge beyond 10 mm
